REPORT OF USATECOM PROJECT NO 8-3-3250-04,
SERVICE TEST OF
KIT FOR MOUNTING DAVY CROCKETT XM29 ON
TRUCK, UTILITY, 1/4-TON, 4X4, M151
9 JULY 1963

SUBJECT: Report of USATECOM Project No 8-3-3250-04

REPORT OF USATECOM PROJECT NO 8-3-3250-04,
SERVICE TEST OF
KIT FOR MOUNTING DAVY CROCKETT XM29 ON
TRUCK, UTILITY, 1/4-TON, 4X4, M151
10 September 1962 - 4 June 1963

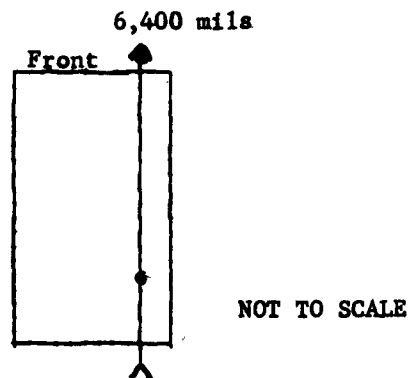
a. The XM29 system was mounted on the M151 vehicle with the Primary Kit. All traverse measurements were measured from 6,400 mils. That point was established with the gun parallel to the longitudinal axis of the vehicle with the muzzle forward (see diagram below).

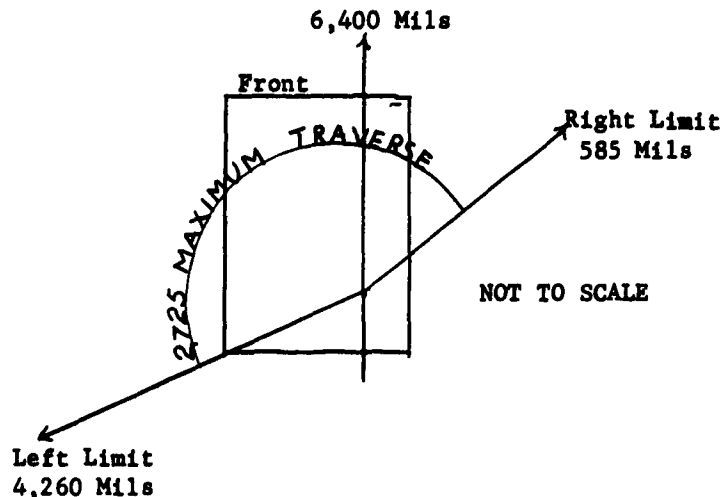
a. Results of firing indicated that the Primary Kit on the M151 vehicle would permit firing of the XM29 throughout a span of traverse of 2,725 mils at gun/vehicle angles from 131 mils to 780 mils without causing damage to the vehicle or stowed equipment except when firing over the hood of the vehicle. When firing over the hood of the vehicle at elevations below 200 mils, damage occurred to the vehicle. The left limit of 4,260 mils was the limit beyond which damage to the vehicle could be expected. Since the gunner cannot climb on the M151 vehicle while laying the XM29 as the lay is disturbed when he dismounts to fire, the right limit of 585 mils was the limit beyond which sighting of the weapon could not be accomplished (see diagram below).

b. No disabling damage occurred to the vehicle when these limits, paragraph a above, were exceeded by 200 mils left traverse. Minor damage that did occur indicates that continuous firing could result in severe vehicle body damage.

c. A method of physically marking the limits of elevation and traverse on the cradle and mount, respectively, is required. These markings should reflect the limits (para a above) determined by this test. The lack of these markings is a shortcoming (Sec 2, Annex C, Part III).

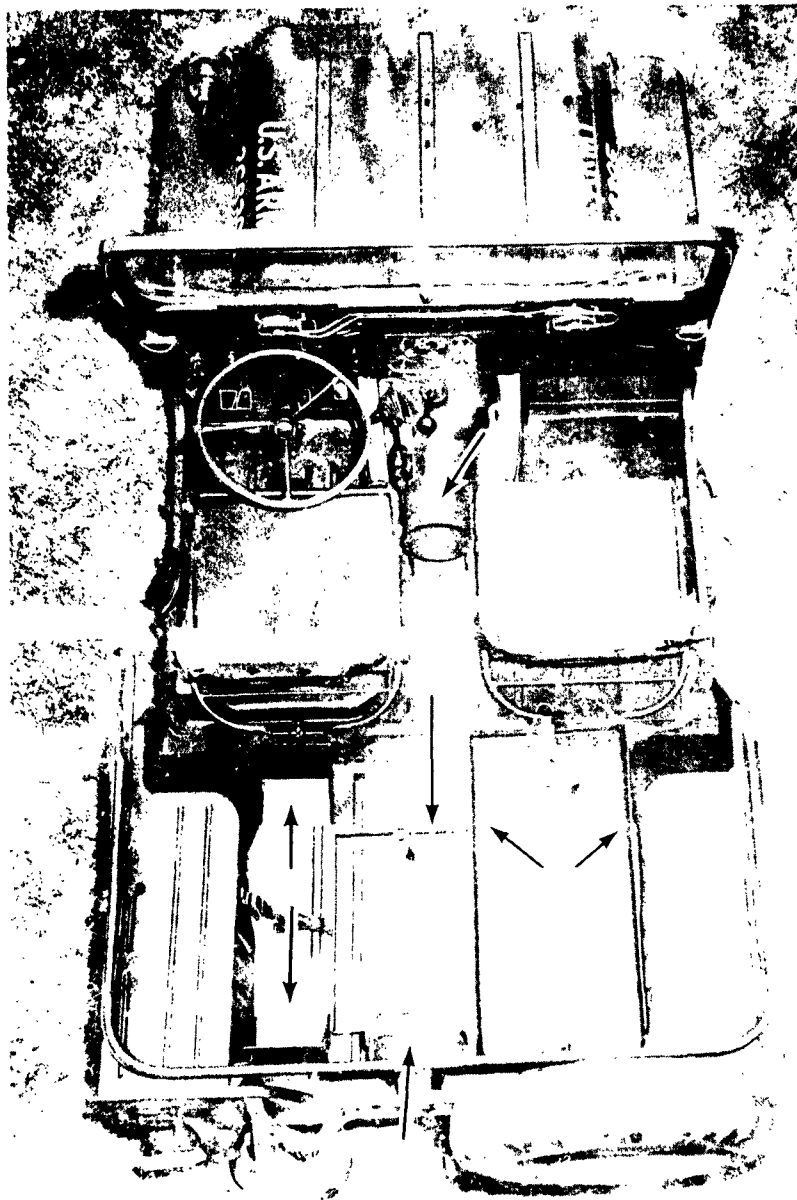
- (a) Major Caliber Projectile Rack (1 Projectile).
- (b) Spotting Ammunition Rack (10-Cartridge Case).
- (c) Piston Rack (1 Each).
- (d) Propellant Rack (1 Each, Zone I and Zone II).

Secondary Kit

- A. Major Caliber Projectile Rack (1 Projectile).
- B. Spotting Ammunition Rack (10-Cartridge Case).
- C. Piston Rack (1 Each).
- D. Propellant Rack (1 Each, Zone I and Zone II).

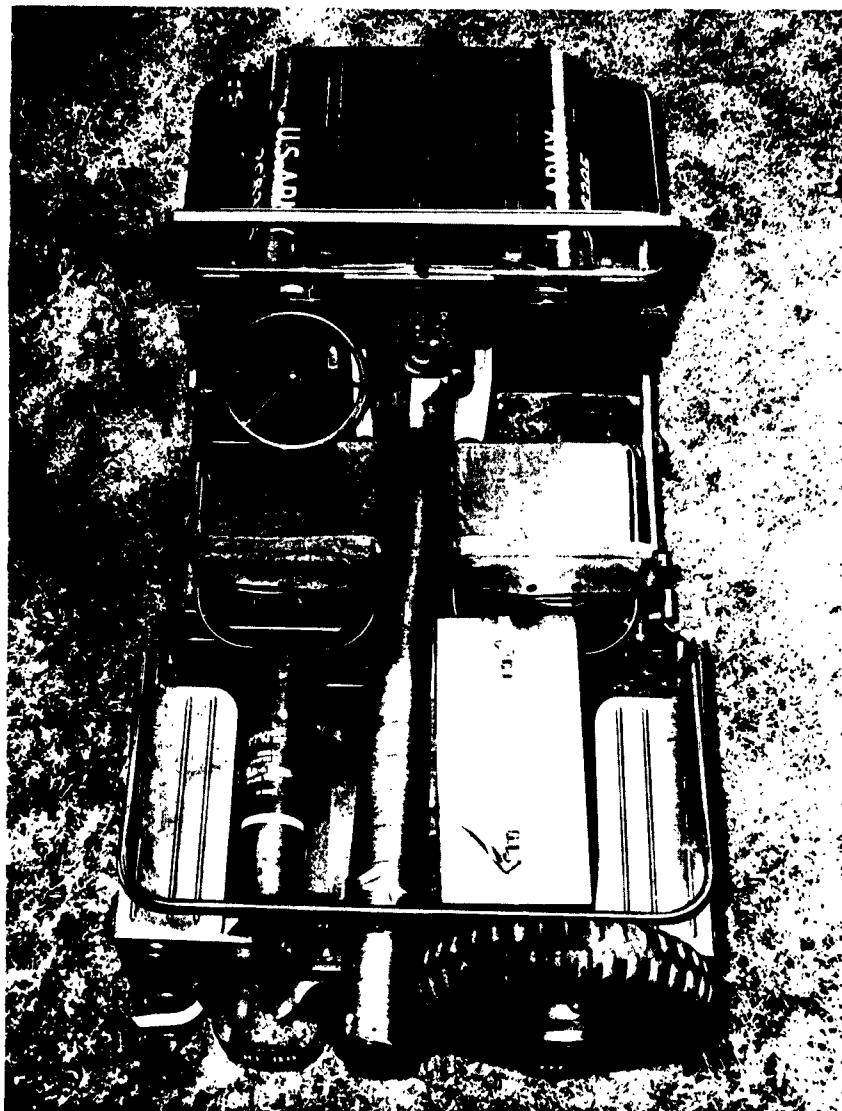
Annex B-4

(2) Provides a means of stowing and transporting sufficient spotting and major caliber ammunition for one fire mission. Space in the M151 vehicle is available for the driver and one other soldier. There is no Heavy Duty Suspension on this vehicle. The M151 vehicle with the loaded Secondary Kit is shown in Annex B-4, Part III.

Secondary Kit with Ammunition for One Fire Mission

b. The Secondary Kit was compatible with the ammunition it was designed to transport; however, the M151 vehicle lacks space for mounting the AN/VRC-10 radio and space for the remaining man of the XM29 squad (Annex B-2 through B-6, Part III). This lack of space for the remaining man of the XM29 squad is a deficiency (Sec 1, Annex C, Part III). The AN/VRC-10 radio weighs over 120 pounds and would further overload the M151 vehicle if spaces for mounting were available. The draft TOE for infantry battalion, ROAD, includes authorization for one 1/4-ton vehicle and one 3/4-ton vehicle (ref 12, Annex A, Part III). It is considered that the 3/4-ton vehicle could provide each squad with adequate crew transport and space for mounting the AN/VRC-10 radio. Additional ammunition also could be carried on the 3/4-ton vehicle (ref 5, Annex A, Part III).

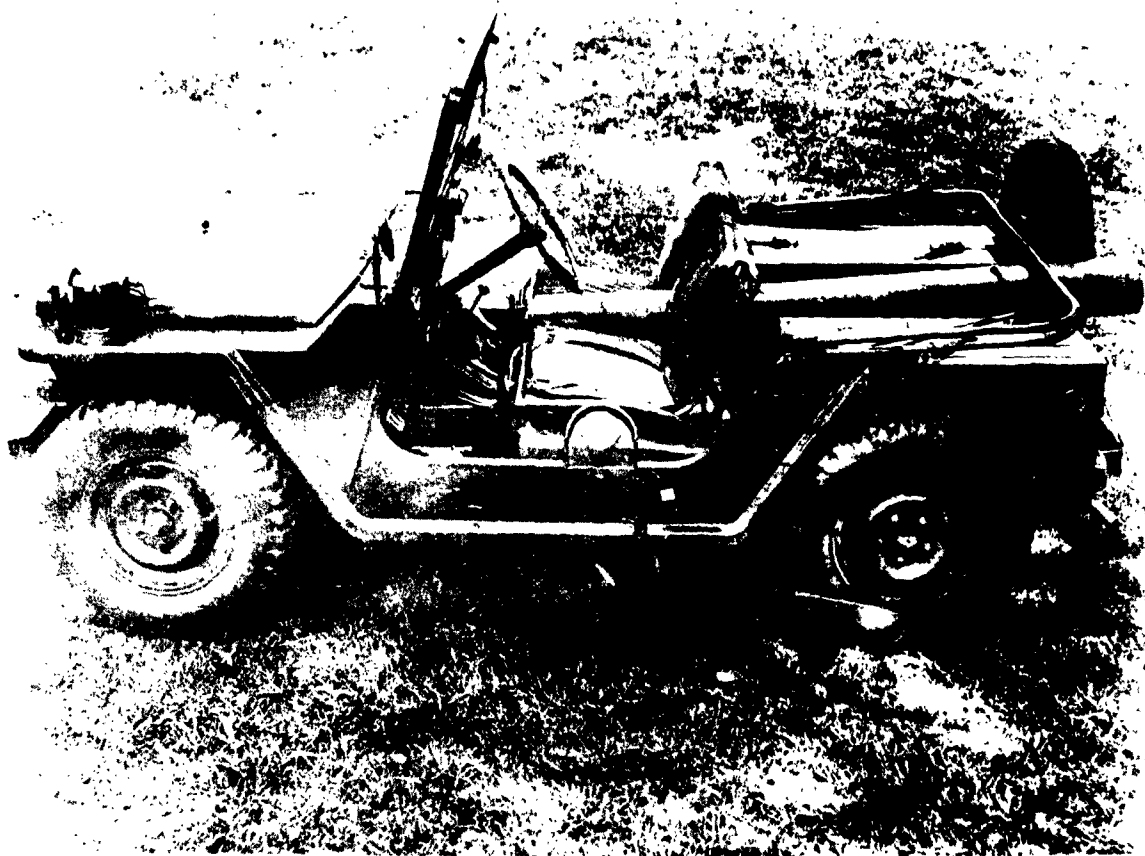
Annex B-5

Secondary Kit (Left Side View)

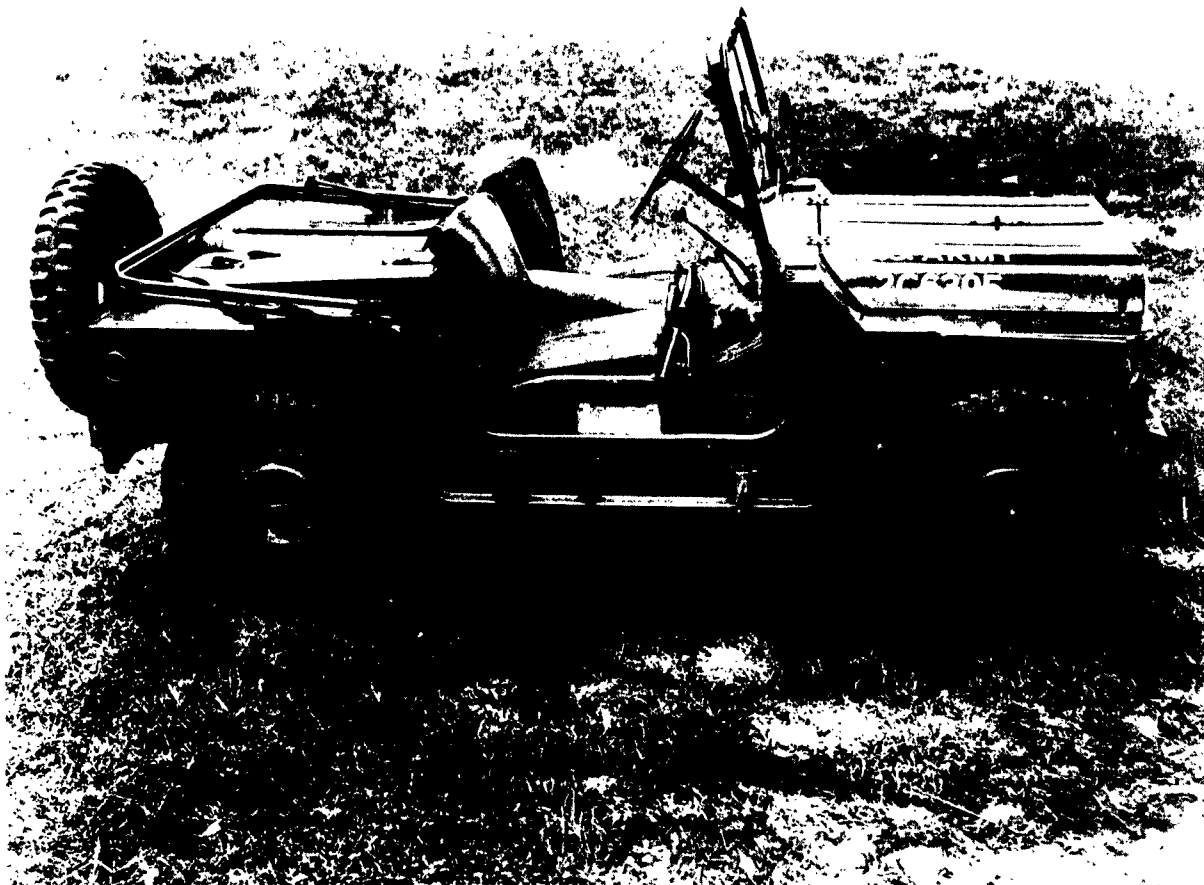
Annex B-6

Secondary Kit (Right Side View)
